EXPOSURE

vol. 8 no. 2

a newsletter for ocean technologists

Aanderaa RCM Compass Errors

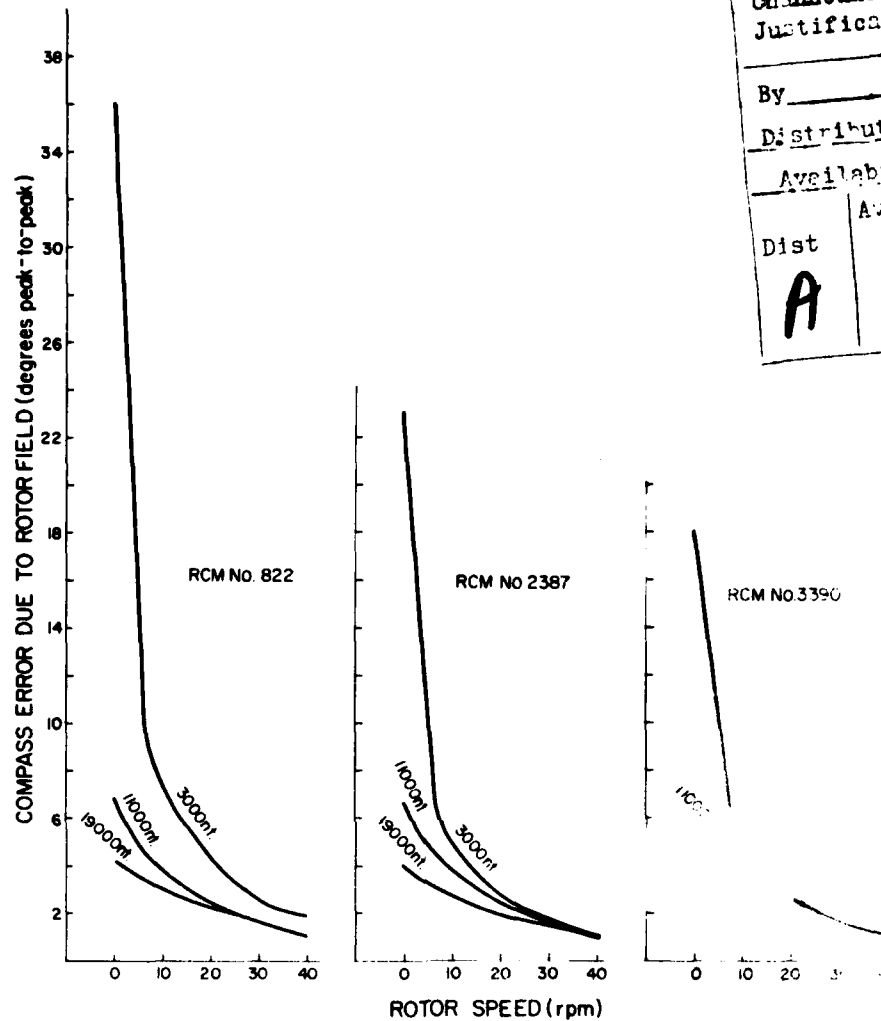
Figure 1. Compass Error Due to the Rotor Field. (1 nt - 1 mma)

The field associated with the rotor and follower magnets will produce a compass error that is dependent on

rotor speed as well as the horizontal field intensity. As can be seen in Figure 1, the combination of low rotor speed and a weak horizontal geomagnetic field can produce large errors. This error can be removed from the compass calibration by arranging to have the rotor spin at a rate of at least 50 RPM during the compass swing. In some cases, this error may be removed from field data by averaging several direction readings, but it should be noted that the combination of low currents, changing directions, and long cycle times may make it impossible to correct for this error.

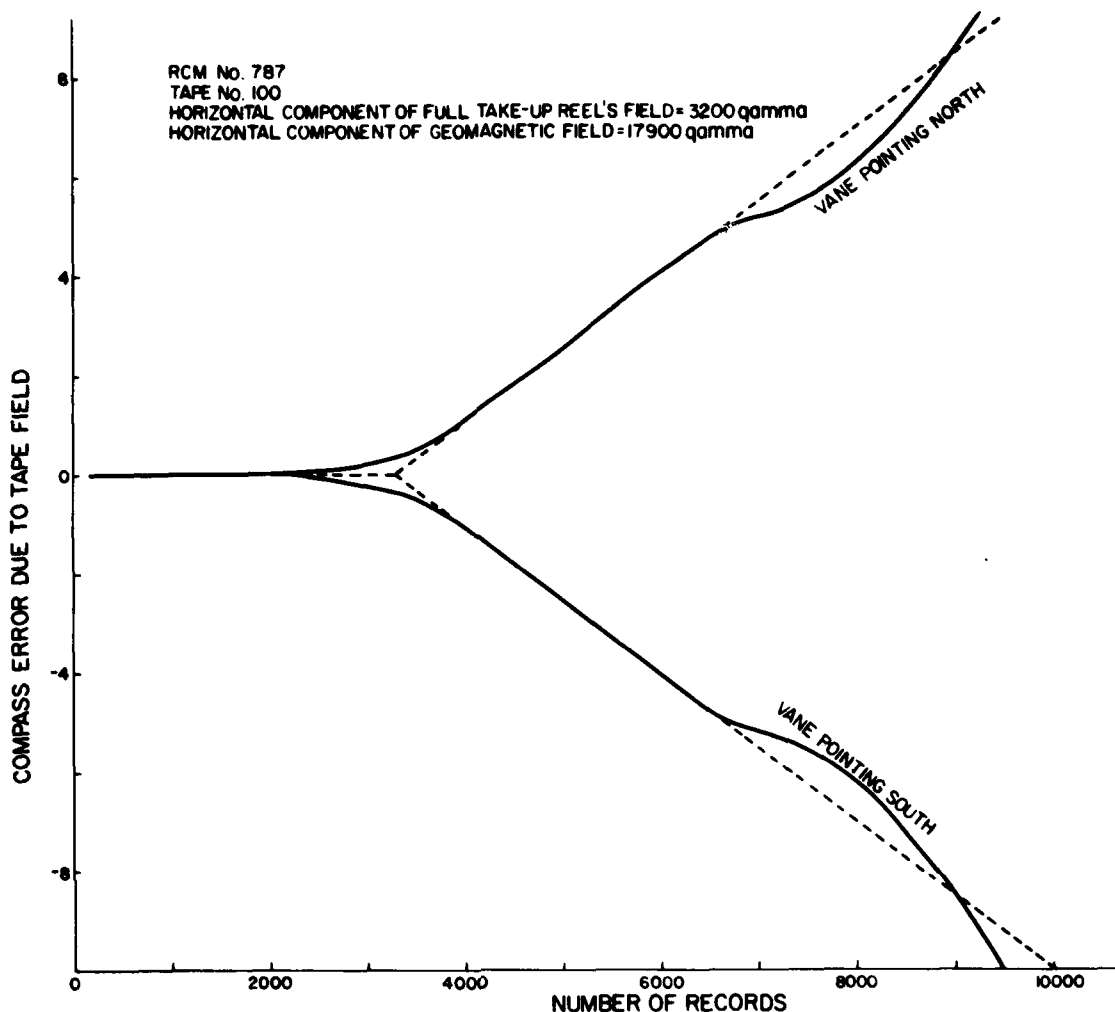
Figure 2. Compass Error Due to an Improperly Degaussed Recording Tape.

The magnetic recording tape, if improperly degaussed, can cause compass errors of up to 4 degrees peak-to-peak in the ambient geomagnetic field at Dartmouth; in areas where the horizontal field intensity is weak ($H = 3000$ gamma) the field about the tape may be of sufficient intensity to lock the compass in a fixed orientation. The error varies from zero when all the tape is on the supply reel to maximum when all the tape is on the take-up reel, as shown in Figure 2. Much experimentation has shown that bulk tape erasers leave residual fields on reels of magnetic tape treated on them. The present practice at BIO is to degauss recording tapes on a modified reel-to-reel tape recorder. This machine has two stereo erase heads mounted in such a manner that their gaps overlap and cover the entire width of the tape. When driven by a suitable erase oscillator, this system leaves only a very small residual field about the tape.
